PUBLIC ROADS

CONSTRUCTING EXPERIMENTAL CONCRETE PAVEMENT IN INDIANA

Page
Experiments With Continuous Reinforcement in Concrete Pavements	205
The Cost of Curing Concrete Pavements With Cotton Mats	215
Cost of Operating Rural-Mail-Carrier Motor Vehicles	217

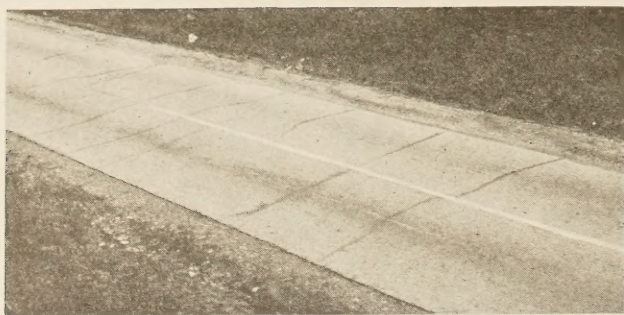
FIGURE 1.—PRESENT APPEARANCE OF A HEAVILY REINFORCED SECTION OF THE COLUMBIA PIKE EXPERIMENTAL PAVEMENT.

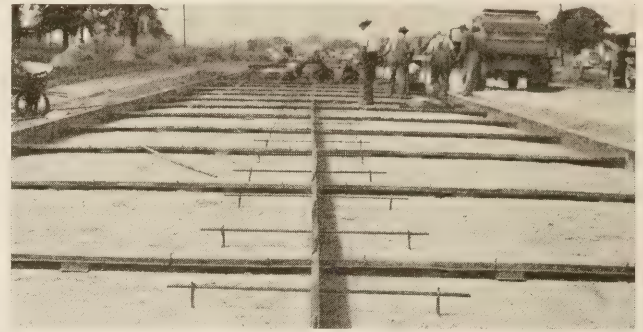
FIGURE 10.—DEVICES USED IN FORMING SUBMERGED WEAKENED-PLANE JOINTS IN PLACE ON THE SUBGRADE.

The submerged type of weakened-plane joints were formed by placing impregnated fiber strips on the subgrade at the points where the joints were to be formed. The height of these strips was varied so as to keep the top uniformly $4\frac{1}{2}$ inches below the top surface of the pavement. A copper seal was placed at the top of the groove so that it would be unnecessary to have a watertight seal on the top surface. Figure 10 shows the submerged weakened-plane joint devices in place on the subgrade before placing the concrete. The dowel shear bars which were placed at one-half of the weakened-plane joints were held in place during concreting by tying them to the longitudinal bars of the fabric.

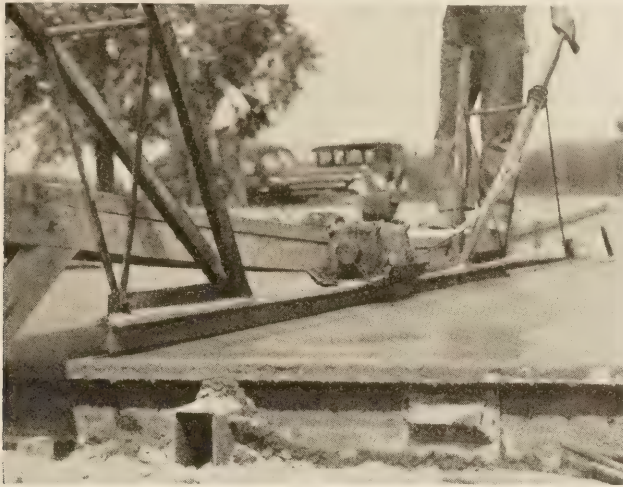
FIGURE 12.—T-BAR AND VIBRATOR USED IN FORMING GROOVES FOR WEAKENED-PLANE JOINTS.

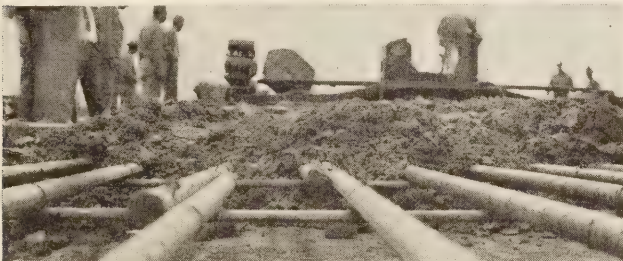
FIGURE 13.—CONCRETE BEING PLACED IN A HEAVILY REINFORCED SECTION.

The concrete mixer was kept to the side of the roadway during the placing of concrete. This allowed the bar mat reinforcement to be placed a short distance in advance of the mixer. The two views in figure 13 show the placing of the concrete in one of the heavily reinforced sections.

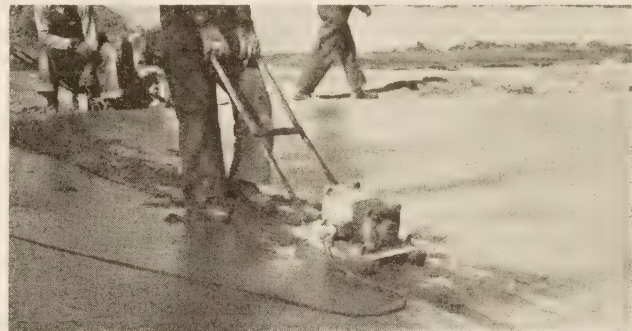
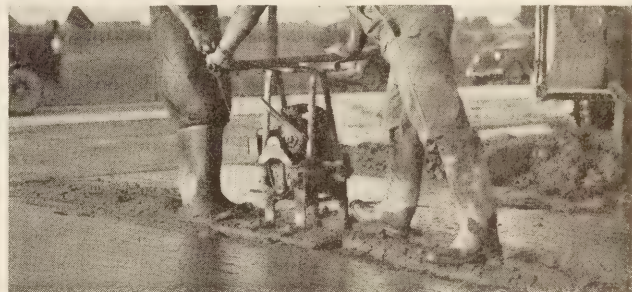
FIGURE 15.—VIBRATORS USED AROUND TYPE III JOINTS. UPPER, VIBRATOR USED ON EAST PROJECT; LOWER, VIBRATOR USED ON WEST PROJECT.

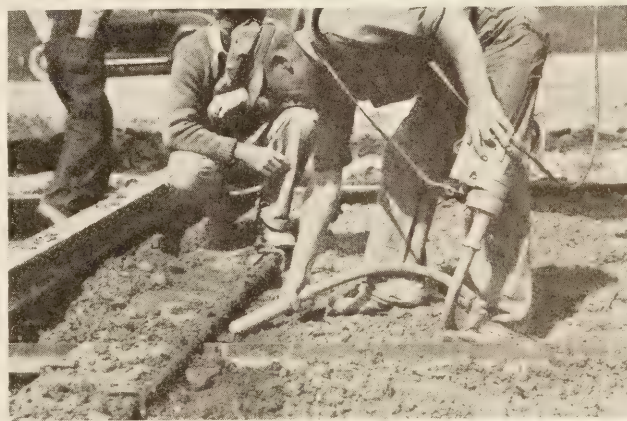
FIGURE 16.—INTERNAL VIBRATOR USED UNDER TYPES I AND II JOINTS.

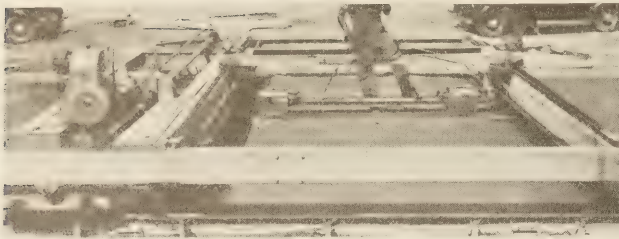
FIGURE 17.—LONGITUDINAL MECHANICAL FLOAT USED ON THE WEST PROJECT.

The concrete was finished in a conventional way, except that a mechanical longitudinal float was used on the west project. This machine is shown in figure 17.

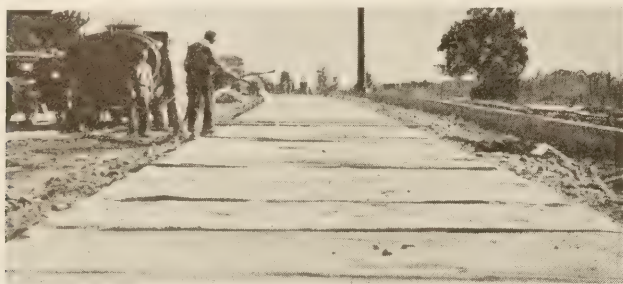
FIGURE 1.—COTTON MATS IN PLACE BEING WET DOWN.

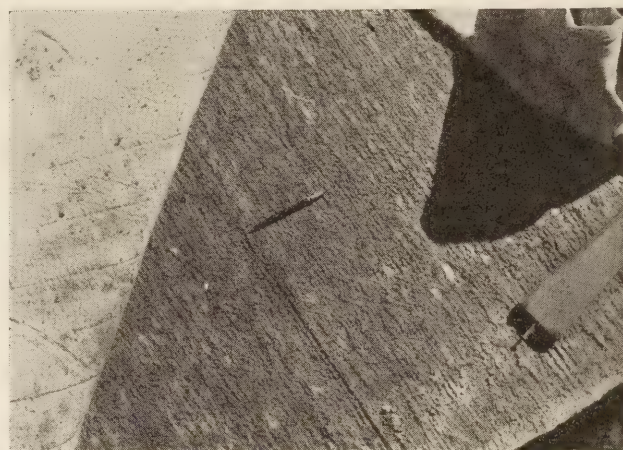
FIGURE 3.—PORTION OF CONCRETE PAVEMENT SLAB AND COTTON MATS USED IN CURING IT.

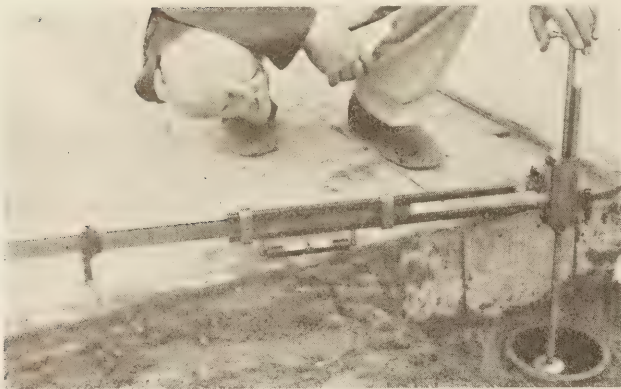
FIGURE 18.—DEVICE USED FOR MEASURING MOVEMENTS AT ENDS OF SLABS, AND BENCH MARK (LOWER RIGHT).

Since the combined movements of the ends of the two slabs at a joint should be equal to the total change in width of the joints, the changes in the widths of the joints are measured as a check on the measurements of the absolute movements of the ends of the slabs. These measurements are made with a micrometer between two metal points set in the concrete.

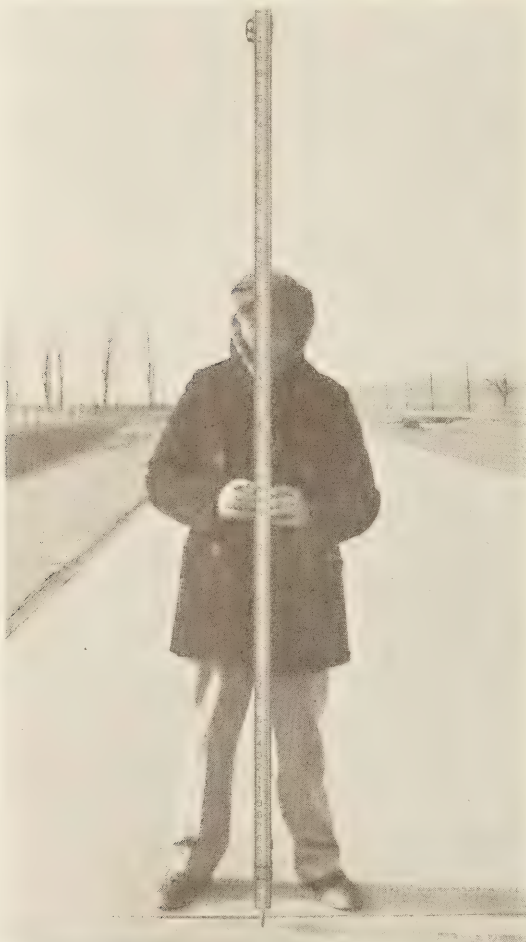
FIGURE 19.—LEVELING ROD WITH SPECIAL ATTACHMENT.

Metal points were set in the concrete at the points where the level measurements are taken. Figure 19 shows a leveling rod resting on one of these points.

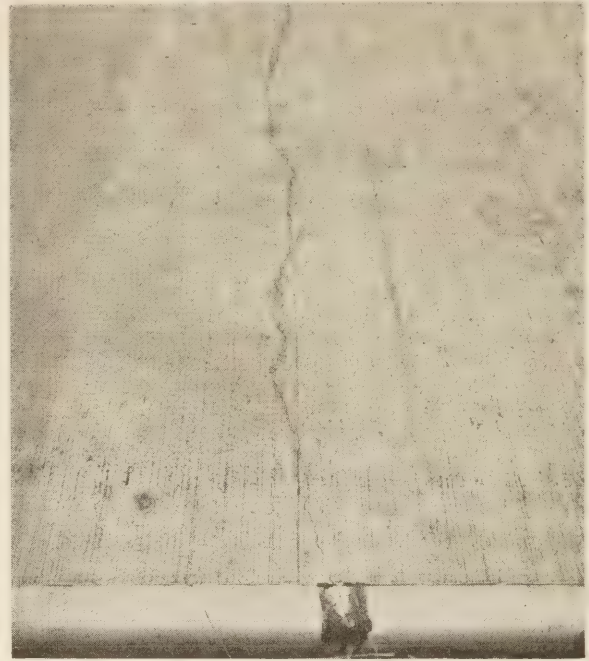
FIGURE 20.—TYPICAL CRACK IN A HEAVILY REINFORCED SECTION.

A typical crack in one of the heavily reinforced sections is shown in figure 20. These cracks are not apparent except on close examination and are very similar to those that occurred very early in the life of the heavily reinforced sections of the Columbia Pike experimental pavement. As stated earlier in this report, the cracks in the heavily reinforced sections on Columbia Pike have remained closed and no serious spalling or disintegration has occurred in their vicinity. It seems unlikely, therefore, that these fine cracks in the heavily reinforced sections of this pavement will ever cause serious damage.

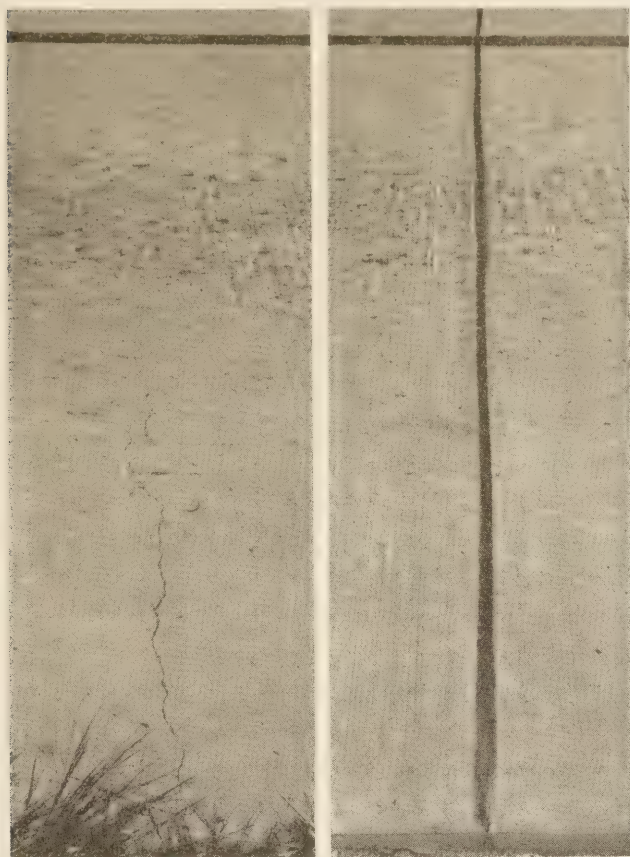
FIGURE 21.—LEFT, CRACK THAT HAS OCCURRED AT A SUBMERGED WEAKENED-PLANE JOINT; RIGHT, WEAKENED-PLANE JOINT WITH SURFACE GROOVE.
